# SAFE ROUTES TO SCHOOL ACTION PLAN

## *Walk Audit Summaries*

TOWN OF CARRBORO • NC

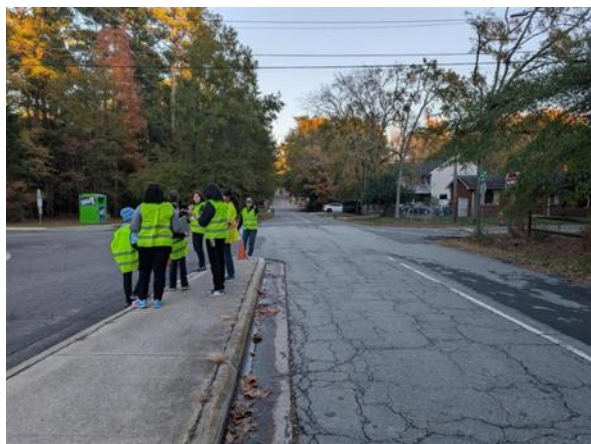
Photo 1: Auditing the Shelton St, Ashe St, and carpool lane intersection

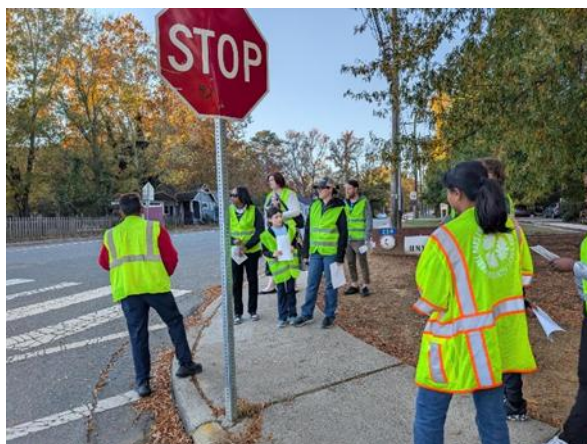
Photo 2: Auditing the Shelton St and Hillsborough Rd intersection

- Implement a pedestrian refuge island and a mid-block crossing on W Main St in front of Lanza's (where the School Zone sign is located)
- Increase visibility at the W Main St and Hillsborough Rd corner
- Document actual speeds along Hillsborough Rd
- Implement speed bumps and/or narrow Hillsborough Rd between Pine St and Shelton St via curb extensions
- Add a flashing/blinking light element to school zone signs
- Repave the existing crosswalk for improved visibility
- Place a stop sign ahead of the crosswalk on Hillsborough Rd
- Address confusion regarding the 2-way to 1-way transition on Shelton St
- Separate the bus and carpool drop-off areas
- Increase lighting on Shelton St
- Add a crossing at Fidelity St
- Implement speed bumps on Hillsborough Rd north of Carrboro Elementary
- Fill in sidewalk gaps along Shelton St

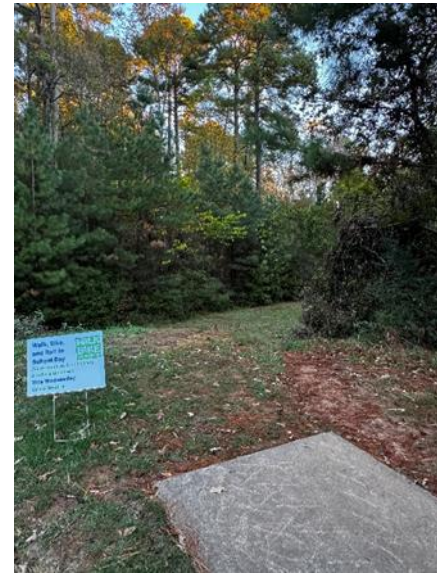
- *Jones Creek Greenway*
  - All participants raised the need to complete the Jones Creek Greenway connection to the Lake Hogan Farms neighborhood. The terrain is steep with many roots, rocks, and other obstacles during the first several yards

Photo 4: Start of the Jones Creek Greenway

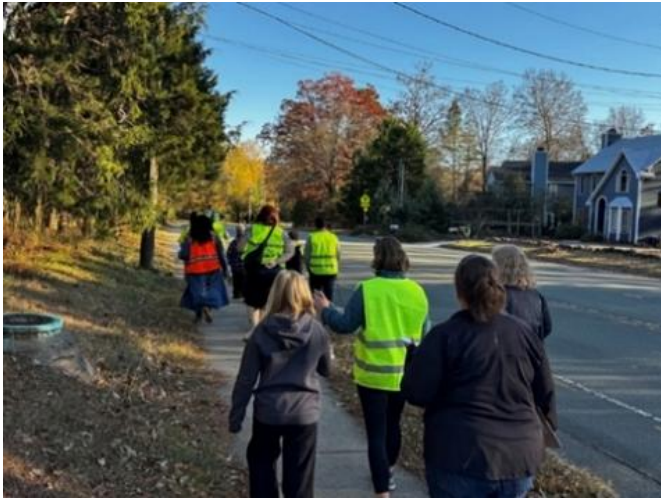
Photo 5: Auditing the Hillsborough Rd route

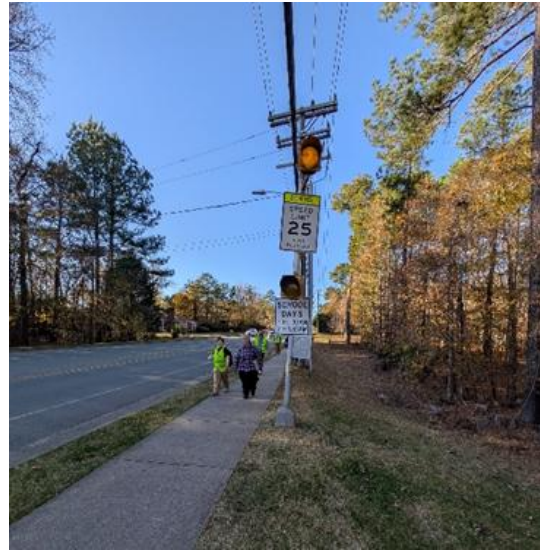
Photo 6: Auditing the Hillsborough Rd route
